Newfane Town Offices Feasibility Study

555 Vermont Route-30
Newfane, Vermont 05345

PROPERTY ASSESSMENT

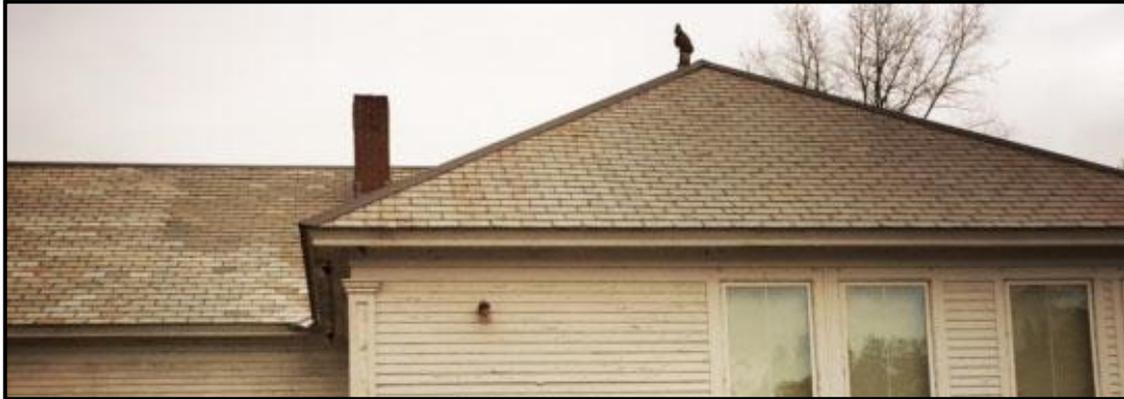
There have been extensive repairs made around the chimney. In the above photo, the darker area shows one of the repairs to the left the chimney, but there is a more recent patch to the right of the chimney.

There are two visible waves on the roof of the 1986 addition; one on the south side and one on the north side. There was no noticeable water damage on the inside to the roof rafters and we could only surmise that the issue was with the roof sheathing.

Steve Marazof, the roofer, suggested that within the next five years, the building be re-roofed with asphalt shingles, a standing-seam metal roof, or imitation slates. There is a difference in price; imitation slates costing more per square than asphalt shingles or standing seam. Please see Appendix and the Estimated Costs Spreadsheet.

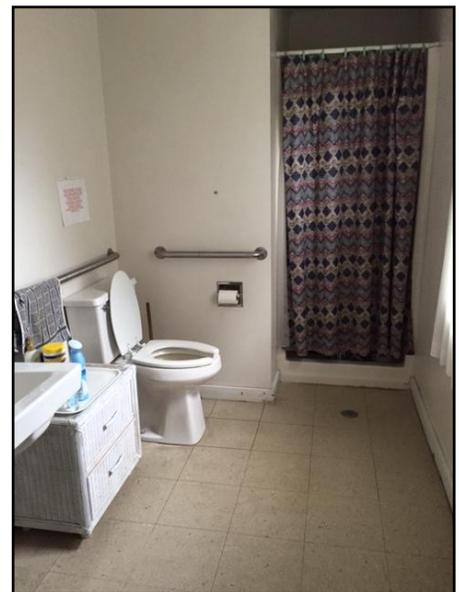
Non-Compliant Toilet Room

When the toilet rooms were designed in 1986, there was no ADA Code with which to comply. To make the toilet rooms compliant, they would need to be enlarged to enable a 5'-0" turning radius. The shower in the Women's Room would need to have a different 1/4" maximum lip or

removed in order to allow the correct sized grab bar along that wall. The lavatories in each room would need to be located closer to the toilets, but maintain the 5'-0" clearance.

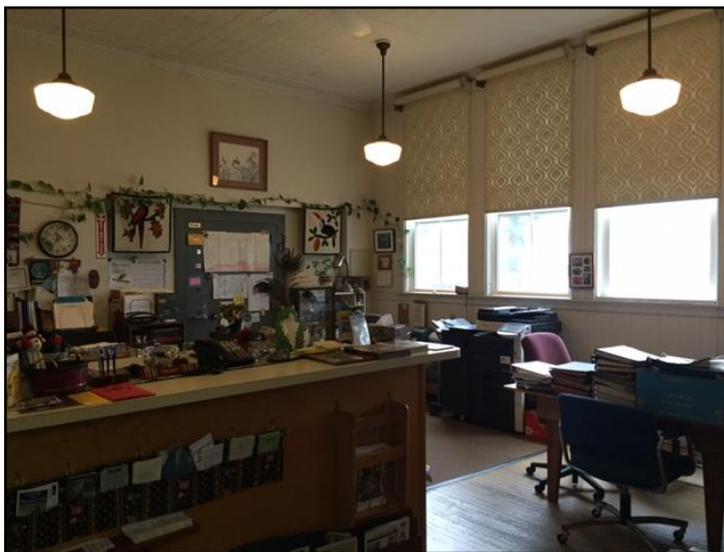
Town Clerk's Office

The Town Clerk has currently maximized the space available in the vault and now requires additional vault space to archive older records that are not used as often.

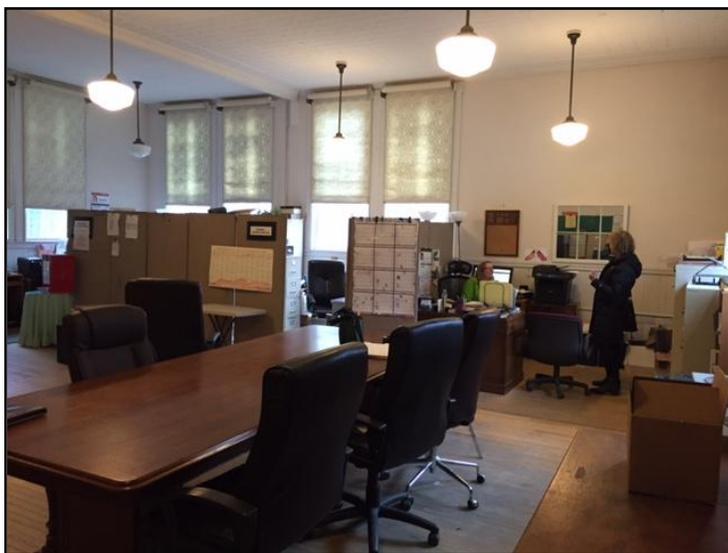
Treasurer, Zoning, Town Administrator & Meeting Area

A serious concern is the lack of privacy. The Treasurer, the Zoning Administrator, and the Town Administrator are in the same room with no walls between them. The challenges include dealing with Townspeople on case sensitive and confidential issues and preventing others from overhearing the conversations. No one can have a private meeting or discuss personnel issues without hearing the discussion.

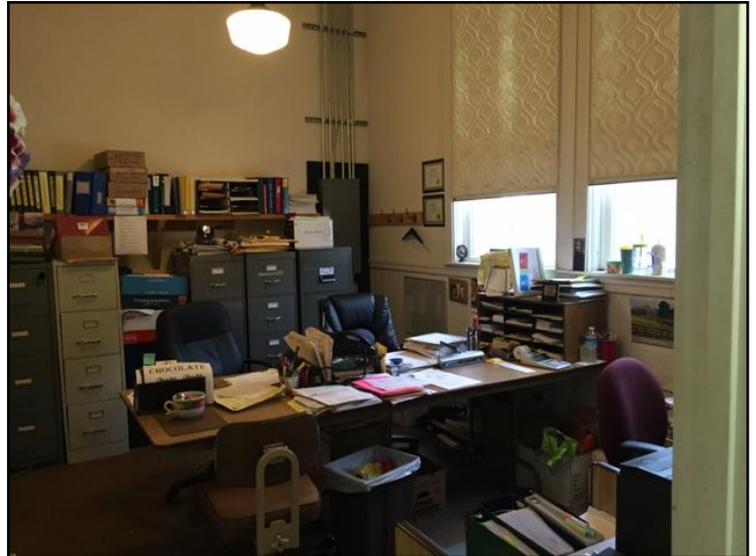
Listers' Office

A similar issue exists in the condition of the Listers' Office. Currently, all three employees are in one room that is 10'-6" x 15'-6" (163 square feet). There are times when all three are in the office together. Phone conversations disrupt the work of everyone else in the room. Files are located behind the double desk, which makes it difficult to access when the desk is in use. There is also no designated area to pull Lister cards or to view maps of the properties when inquiries are made. A designated space for the Townspeople to look at cards would be useful and make a workspace available to the Listers.
