Newfane Town Offices Feasibility Study

555 Vermont Route-30
Newfane, Vermont 05345

PROPERTY ASSESSMENT

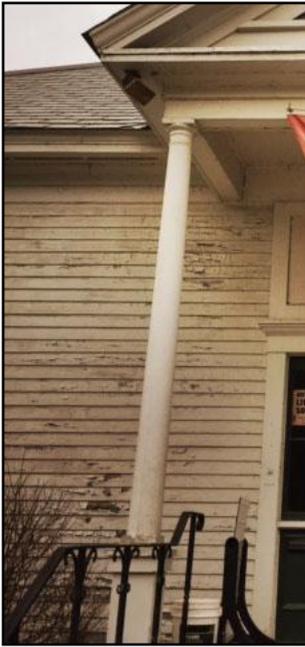
The siding consists of wood clapboards in generally good condition. On the front of the building, there are some clapboards that have rotted and need to be replaced to the left of the front door above the water table board. This condition occurs on each side of the original building and in some instances, the water table also needs to be replaced.

The building should be tested for lead paint and if present, scraped as necessary, and disposed of by a lead paint certified professional. The building is in desperate need of painting and should be primed and painted with a quality exterior paint.

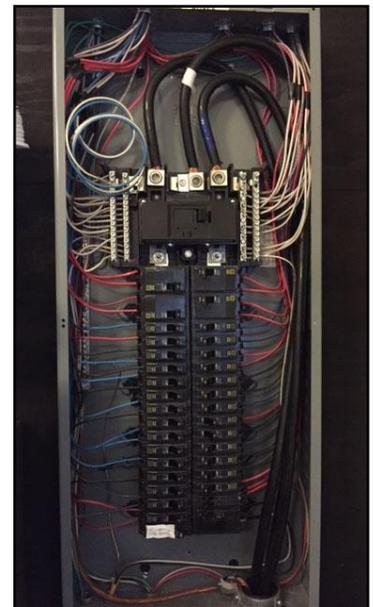
Bill Lockerby, a master electrician from Lawrence & Lober in Bellows Falls, looked at the panel and thought, without taking amperage readings, that there was enough service to add outlets, lighting, and an air conditioning unit to handle the entire building, and remove the window units. If we utilize the Second Floor for additional office space, then the service could be increased by Green Mountain Power in order to install an elevator, if required by Code or desired by the Town.

The electrician suggested wiring from the existing service, a new 100 amp panel to feed the new addition.

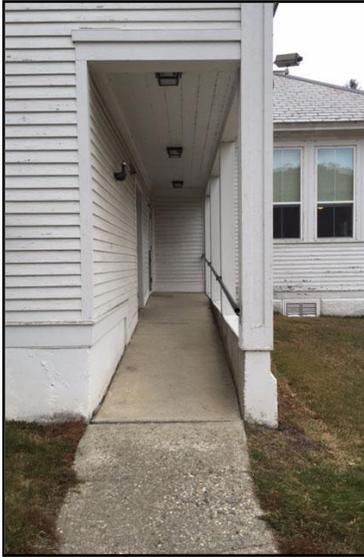
The access ramp, to comply with the ADA, requires handrails on both sides, so a railing should be installed on the building side of the ramp as well.

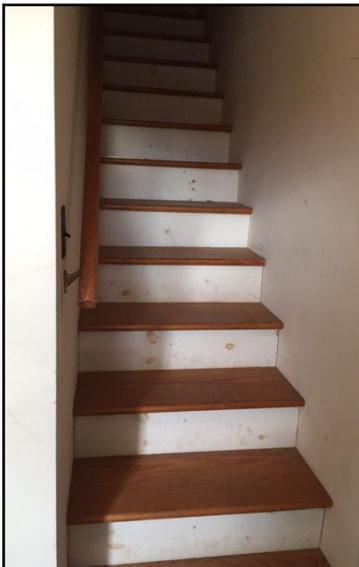
The existing stair to the Second Floor is not code compliant. It is too narrow and too steep.
